Prepared for: Riviera Dunes Marina, Palmetto, FL

## Floating Dock Assessment Report

Submitted: June 2024

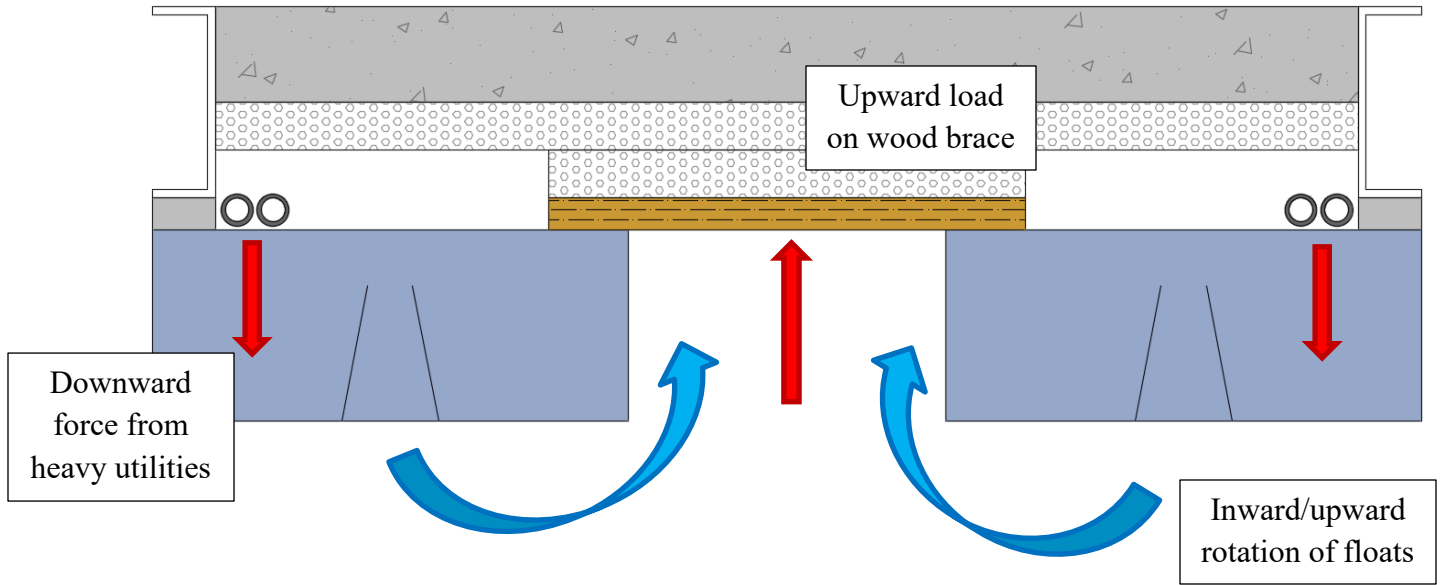
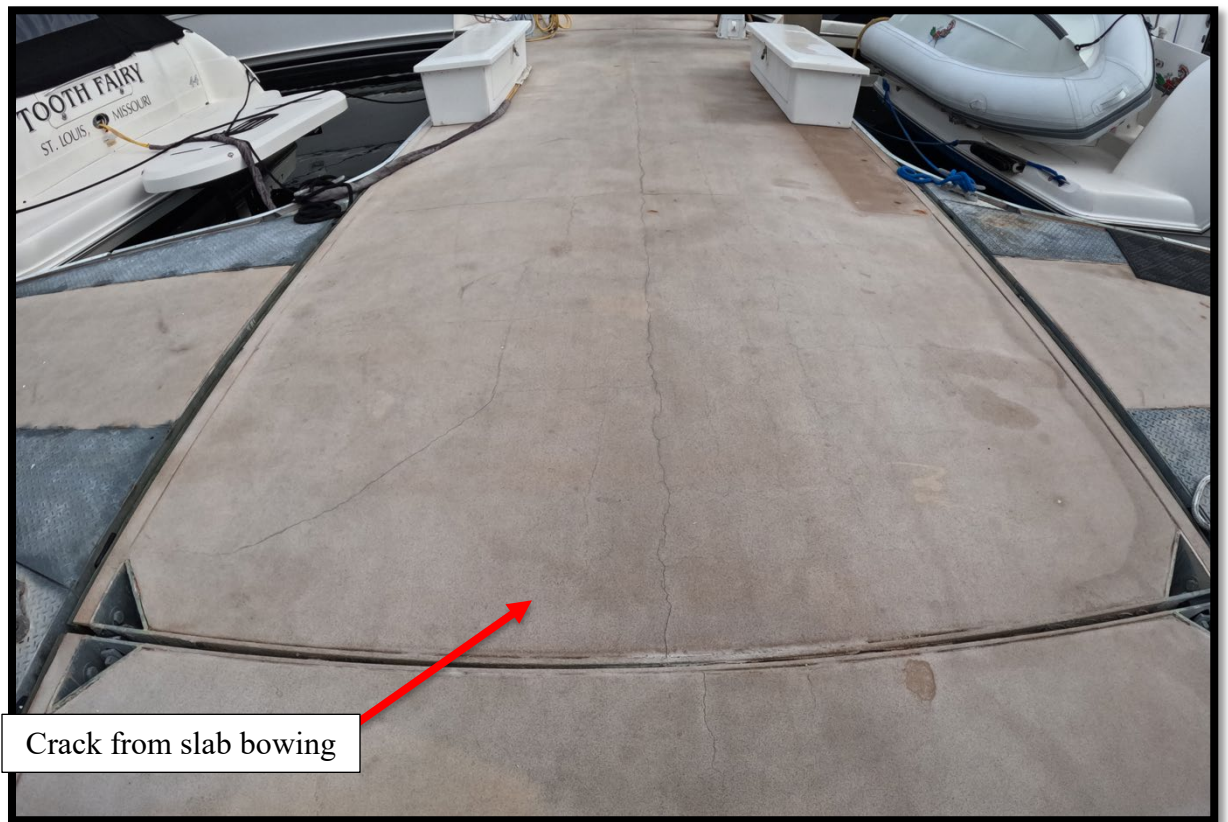
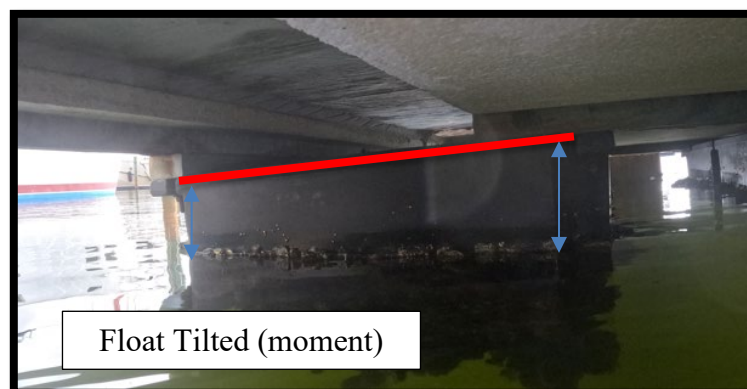
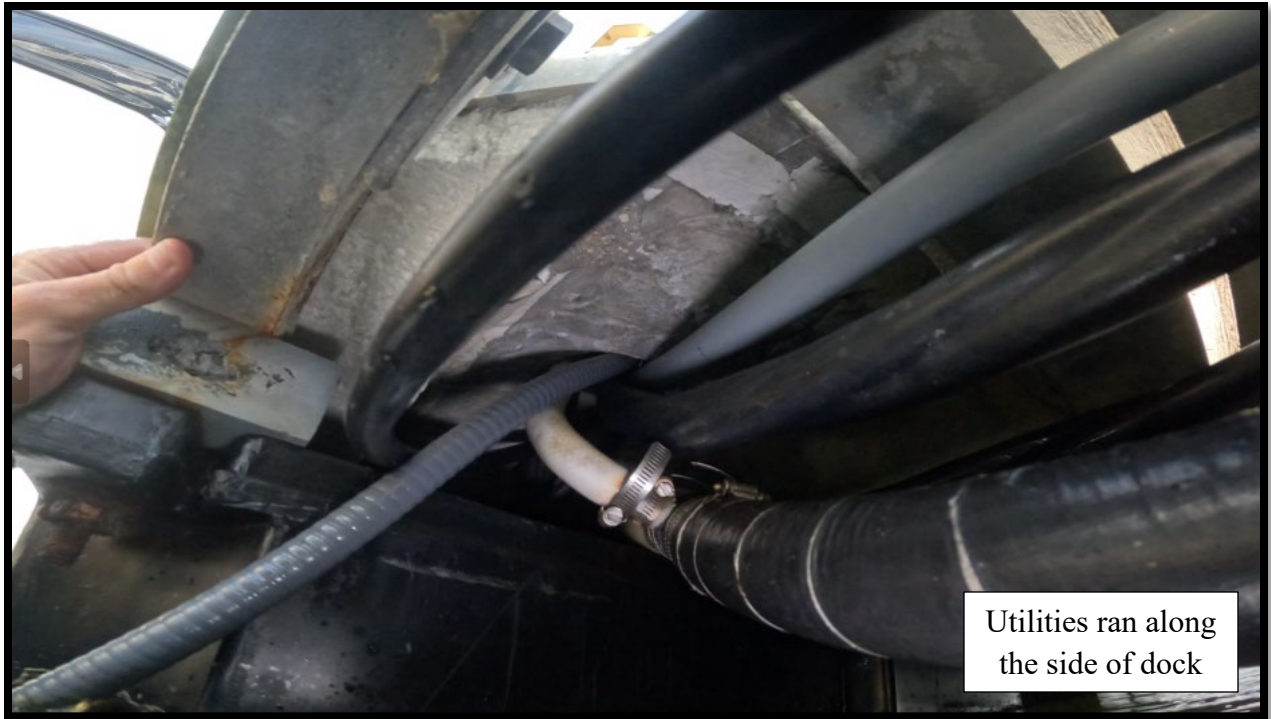
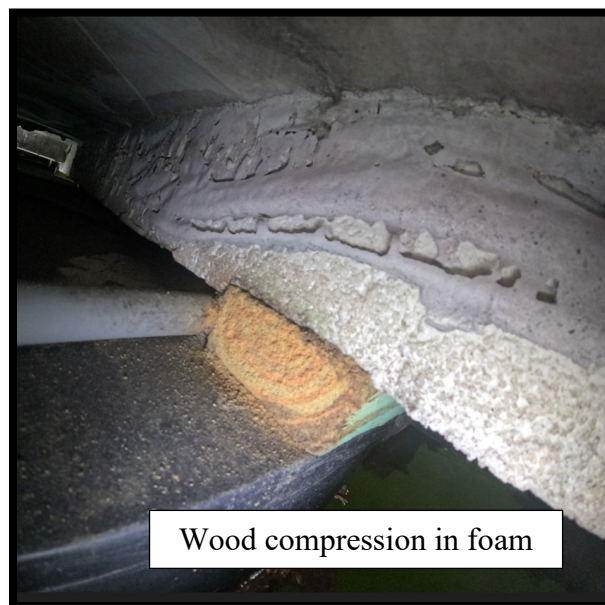
- 1) **Bowing/Crowning of Concrete Deck Slabs** – A common defect found in the majority of the floating docks is visible upward bowing of the concrete deck slabs. This causes cracking in the deck slabs, with rust stains present indicating the internal rebar is beginning to corrode and deteriorate. The internal rebar that is corroding is the top cord of the dock truss system, the lower cord is the wood block that spans between the poly floats. It was noted that this bowing is more prominent in the South Docks rather than the North Docks. The likely reason for this difference is that the North Docks have a rigid foam that underlays the concrete deck slab. This added rigid foam stiffens the upper slab that has the corroded rebar. Given that the utilities are NOT acting over the centroid of the float, a moment is created which is causing the floats to push upward in the middle.

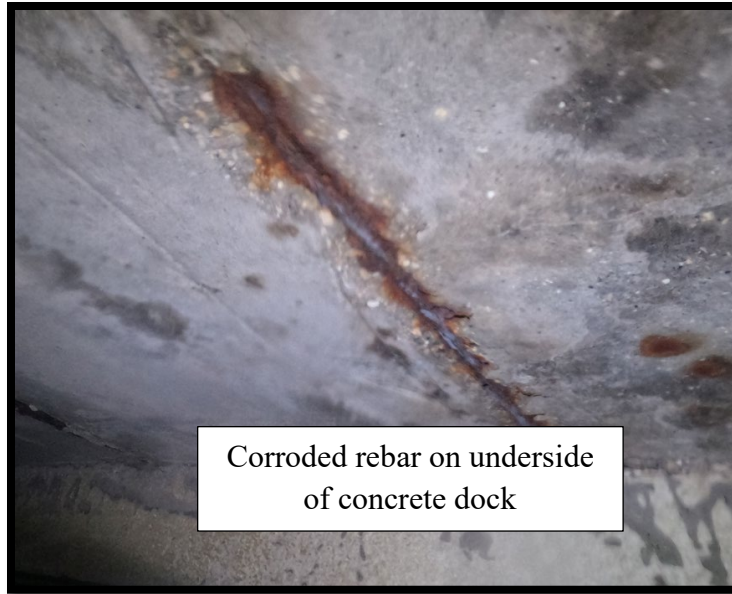
- 2) **Underside of Concrete Deck Corrosion** – Where the finger piers and docks are most exposed to wave action, it was observed that longitudinal cracks and spall were occurring on the underside of the concrete slab. This is evidence that the internal steel within the concrete is corroding.

Corroded rebar on underside  
of concrete dock

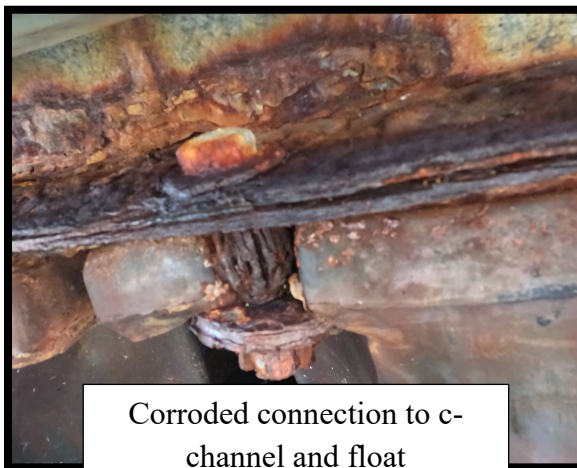
- 3) **Float to C-Channel Connection** – The connection between the float and the c-channel is completed with a through bolt and nut. Given that that this can be a high stress point in the channel and the bolt/washers can retain moisture it often develops rust. This connection keeps the floats in place. It was observed that sporadic repairs were completed at this connection by a bolt/washer/nut replacement, some areas also had added steel channel to help with this connection.

Corroded connection to c-  
channel and float

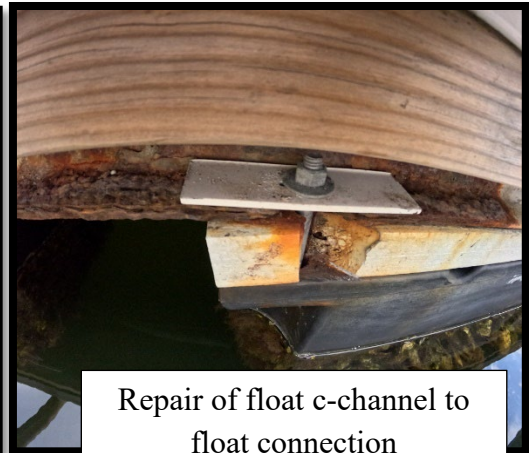
Repair of float c-channel to  
float connection

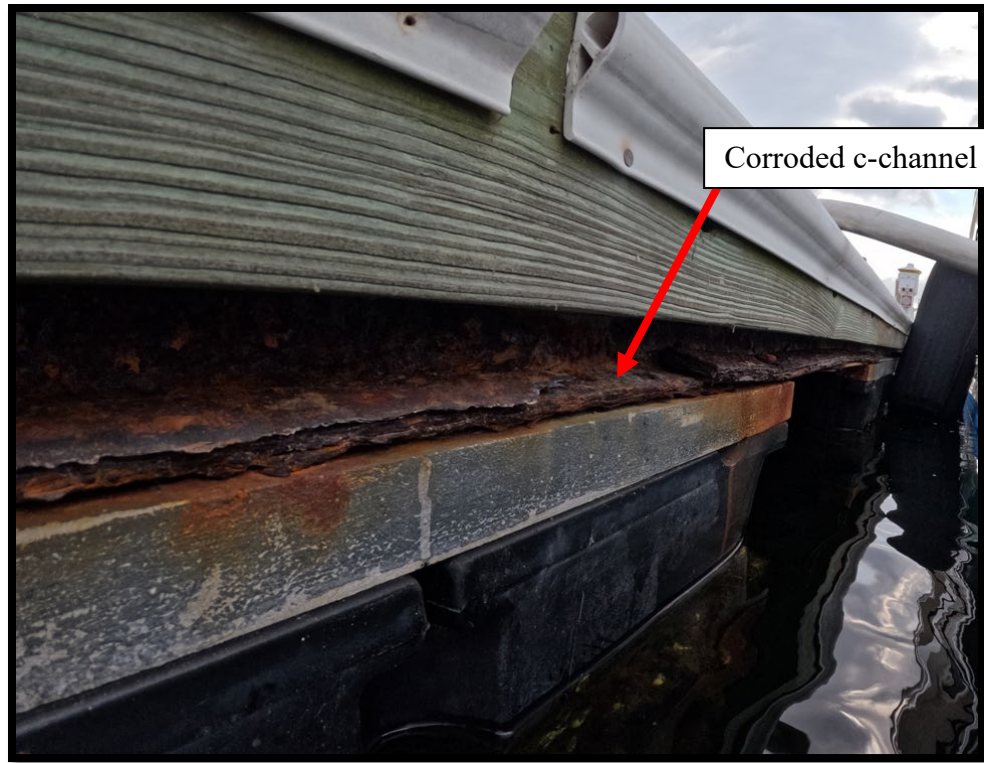
- 4) **Corroding C-Channel** – A prevalent defect in the floating docks is the corrosion of the c-channel which joins the deck slab to the floats underneath. In some extreme cases, there was visible material loss, such that the through bolts providing connection to the floats had no material to bear upon. The outer finger piers exposed the greater amount of wave action and sea spray are in poorer condition, which should be anticipated.

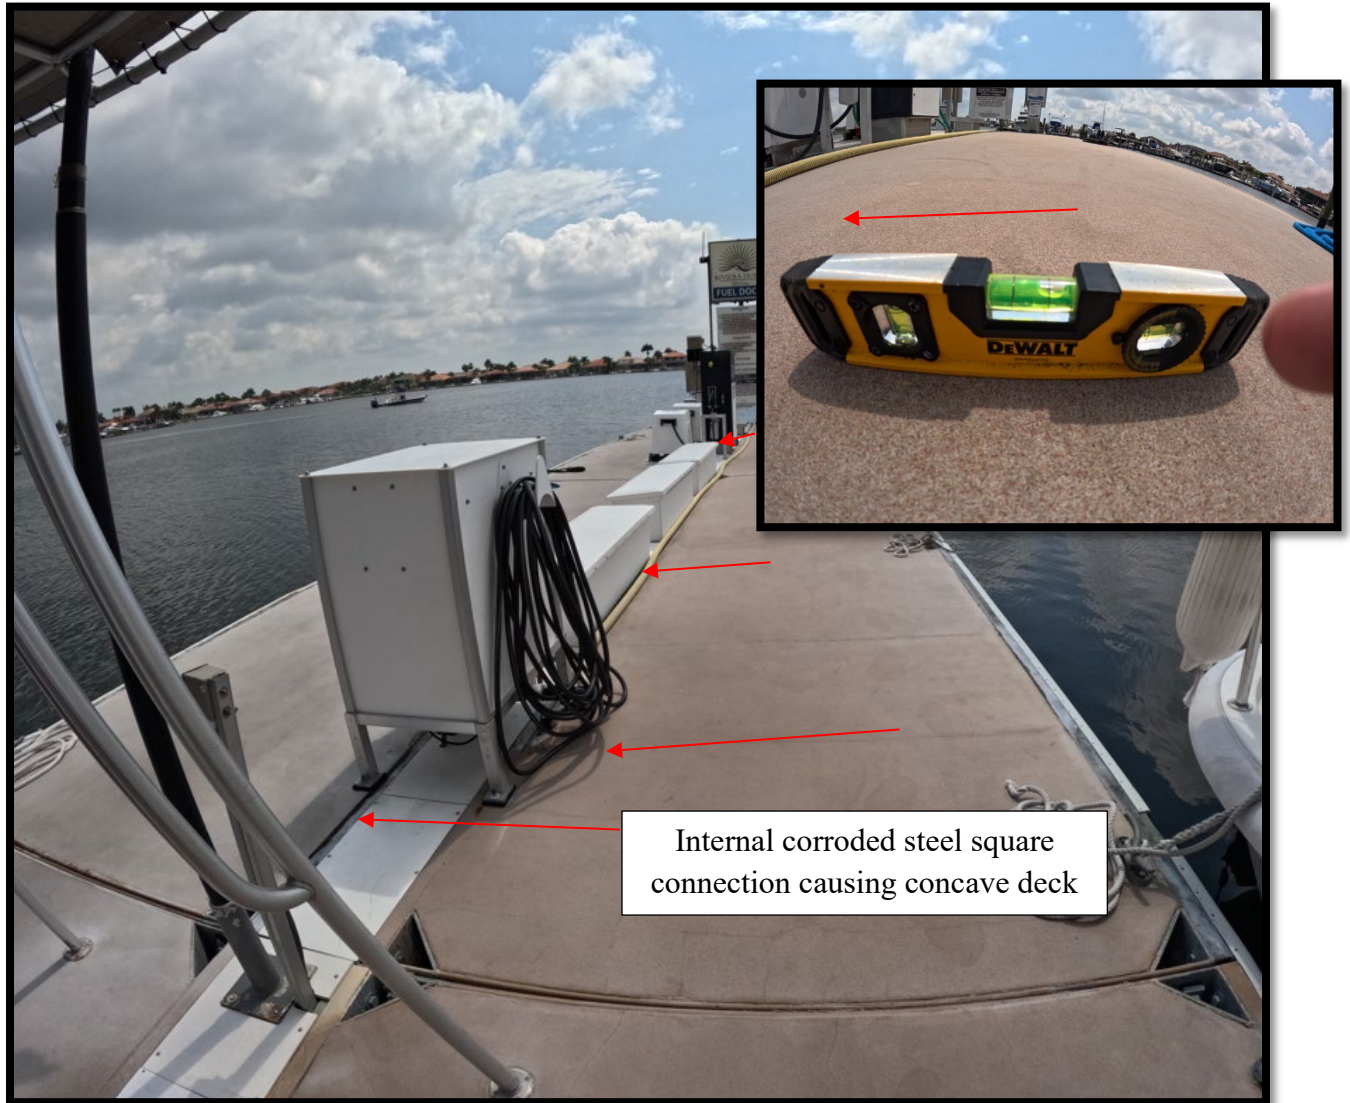
The gas dock steel frame also has significant deterioration, and the centerline of the dock is more concaved in comparison to the other docks where the centerline is more convex. This is because the gas dock is composed of two floating docks that are bolted together with a square steel

connection where the heavy utilities are run. The square steel connection has significant rust, and the connection is starting to fail which is causing the dock to be more concave.

**Phase 1** – Given that the gas dock is a significant revenue source for the marina, and the utility lines that service this dock run along the South Dock, and the South Docks are in the poorest condition, it is recommended that these docks be replaced first. Additionally, a fuel spill could result in significant fines from environmental agencies, should a line break.

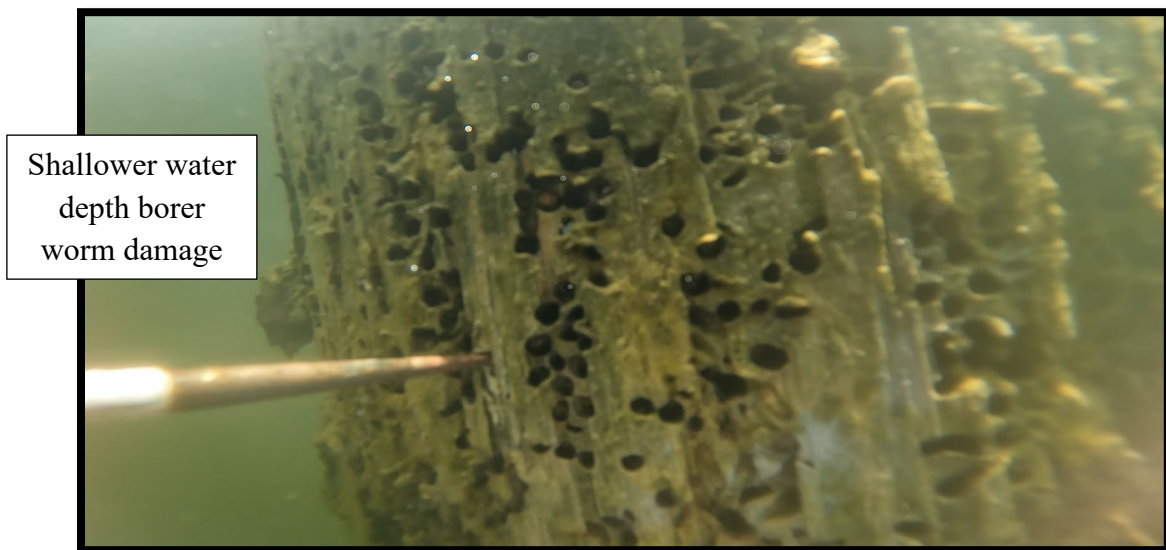
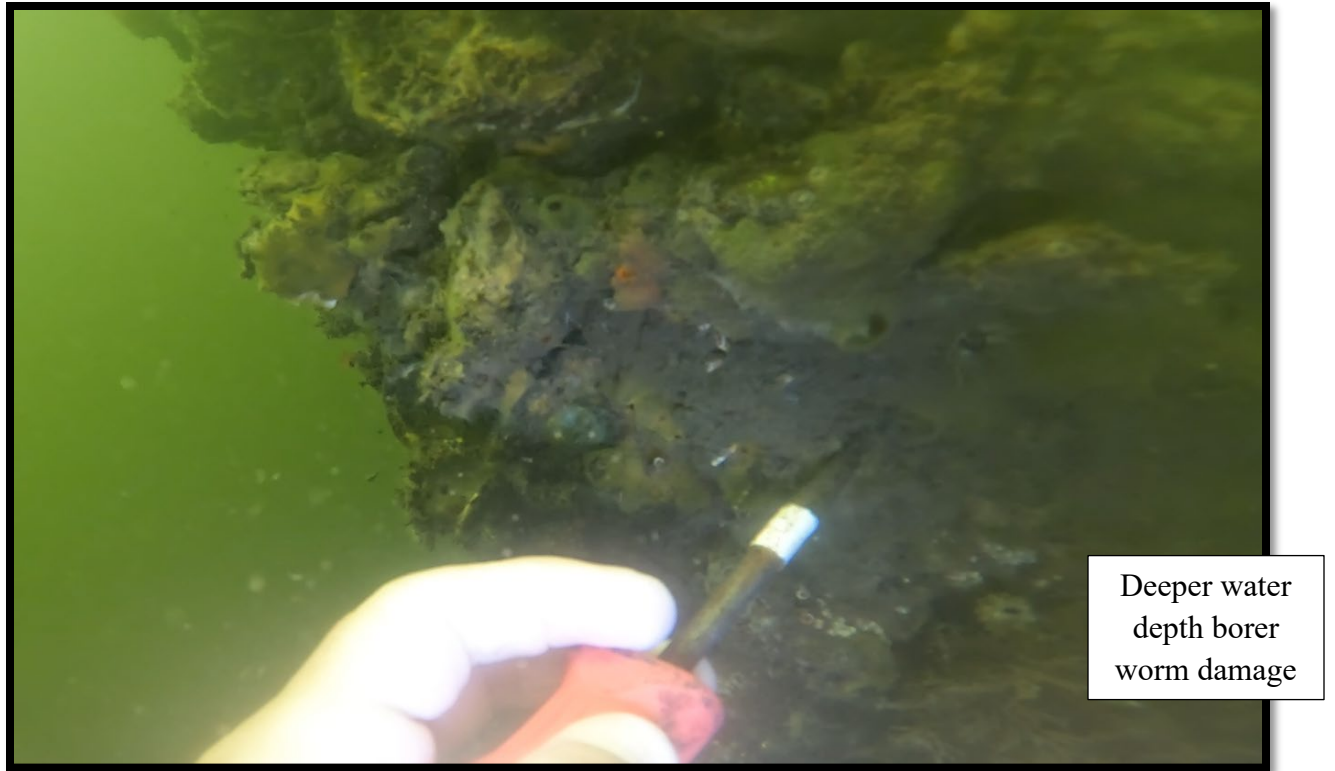
**Wood Piles** – A prevalent defect observed in the wood tie piles is borer worm damage, possibly from the teredo worm, *Teredo navalis*, as they are commonly found in these local waters. These wood destroying organisms penetrate the pile, thereby creating voids which reduces the strength and stability of the piles.

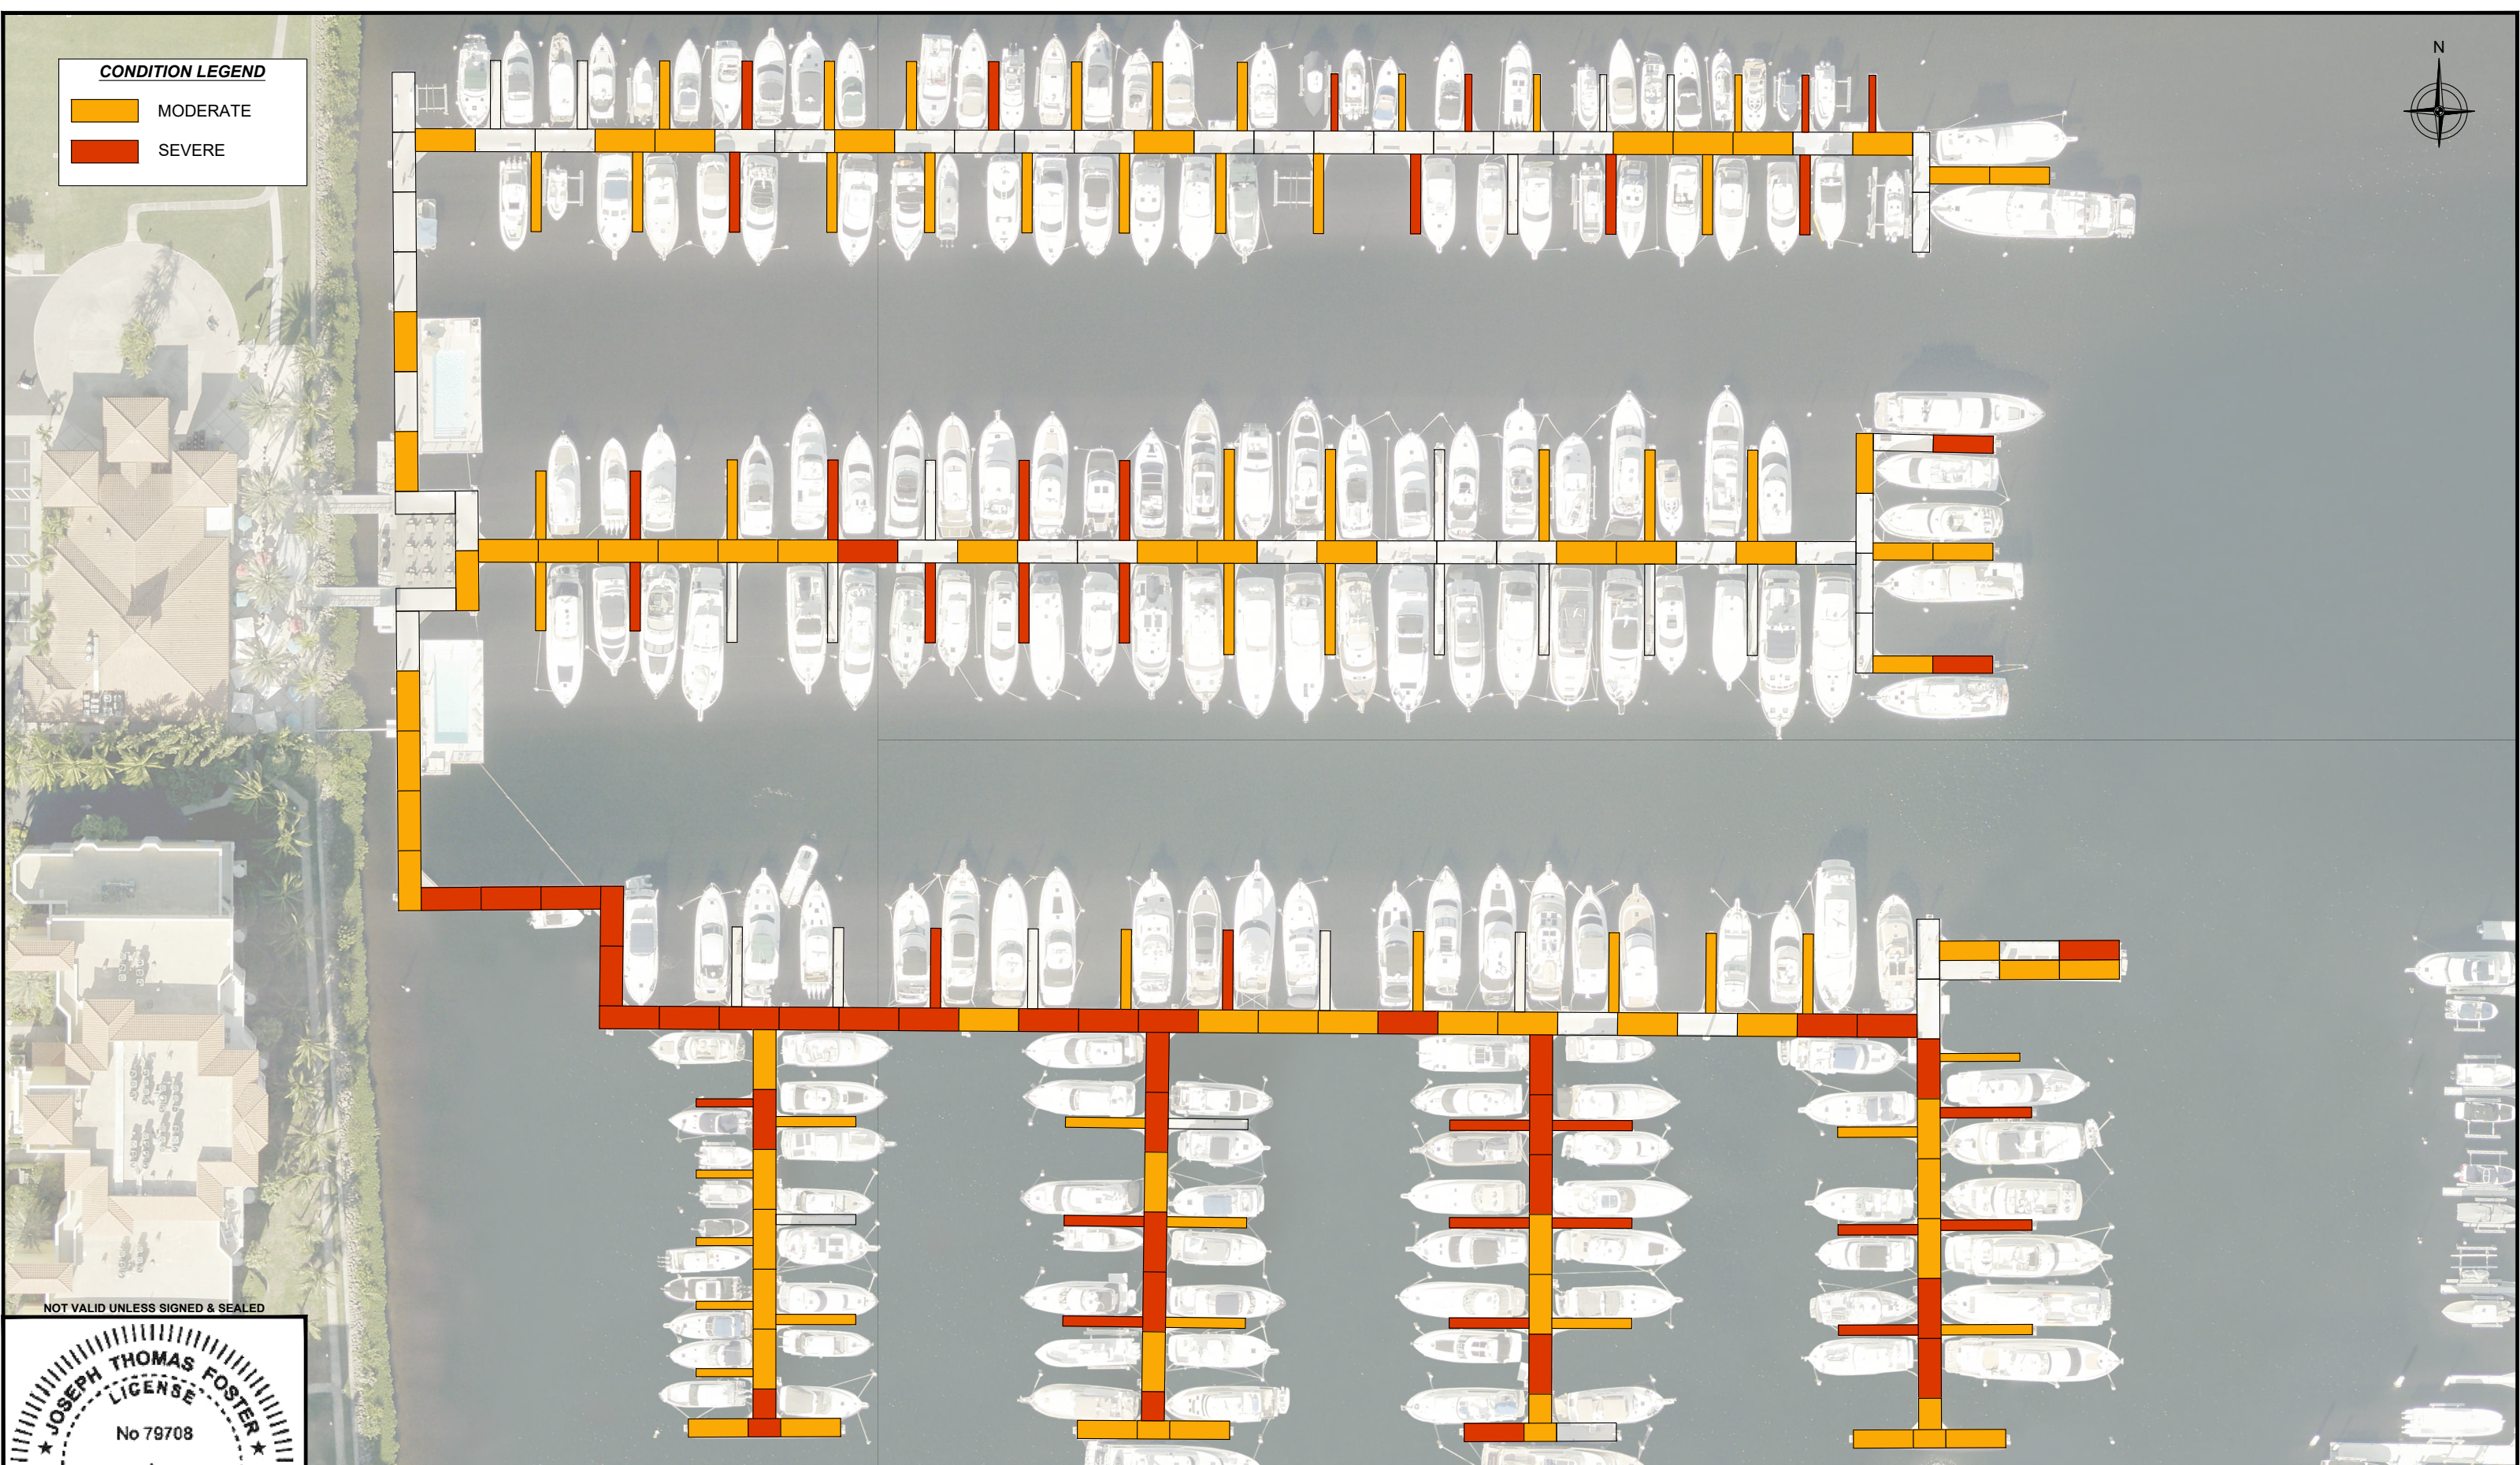
Deck Slab/Finger Pier Condition Map

Approximately 28% of the docks and finger piers in the western third are in usable condition, approximately 27% of the docks and finger piers in the center third are in usable condition, and approximately 22% of the docks and finger piers in the eastern third are in usable condition. It was also observed that the rate of “Severe” or “Very Poor” condition was far greater in the docks located in the eastern third (see Appendix A).
