Prepared for: Riviera Dunes Marina, Palmetto, FL

## Floating Dock Assessment Report

Submitted: June 2024

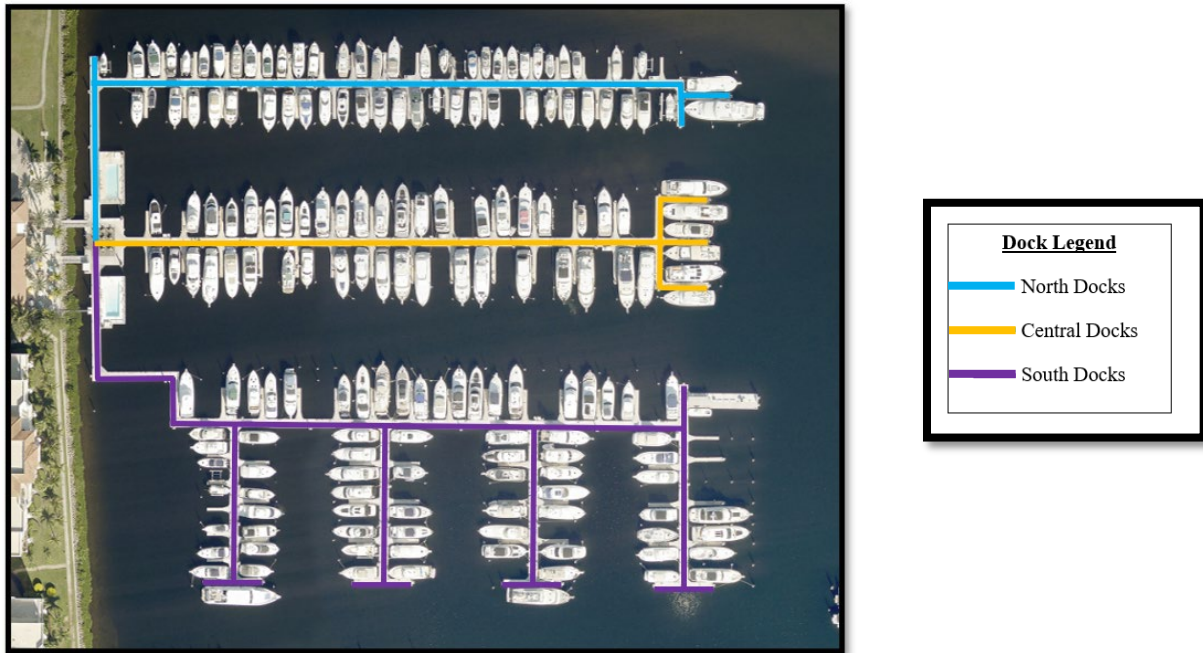
For the purposes of this report, the subject floating docks have been broken down into three sections, based on location and condition. See site map below.

<b>Total Count</b>	<b>As a Percentage of Dock Section</b>
<b>North Docks – Severe</b>	16	43%
<b>North Docks – Moderate</b>	6	16%
<b>North Docks – Minor</b>	15	41%
<b>Central Docks – Severe</b>	18	49%
<b>Central Docks – Moderate</b>	9	24%
<b>Central Docks – Minor</b>	10	27%
<b>South Docks – Severe</b>	39	53%
<b>South Docks – Moderate</b>	18	25%
<b>South Docks – Minor</b>	16	22%

<b>Total Count</b>	<b>As a Percentage of Dock Section</b>
<b>North Docks – Severe</b>	0	0%
<b>North Docks – Moderate</b>	13	36%
<b>North Docks – Minor</b>	23	64%
<b>Central Docks – Severe</b>	3	8%
<b>Central Docks – Moderate</b>	3	8%
<b>Central Docks – Minor</b>	31	84%
<b>South Docks – Severe</b>	34	43%
<b>South Docks – Moderate</b>	37	47%
<b>South Docks – Minor</b>	8	10%

<b>Total Count</b>	<b>As a Percentage of Dock Section</b>
<b>North Docks – Severe</b>	10	30%
<b>North Docks – Moderate</b>	18	55%
<b>North Docks – Minor</b>	5	15%
<b>Central Docks – Severe</b>	8	31%
<b>Central Docks – Moderate</b>	10	38%
<b>Central Docks – Minor</b>	8	31%
<b>South Docks – Severe</b>	14	36%
<b>South Docks – Moderate</b>	18	46%
<b>South Docks – Minor</b>	7	18%

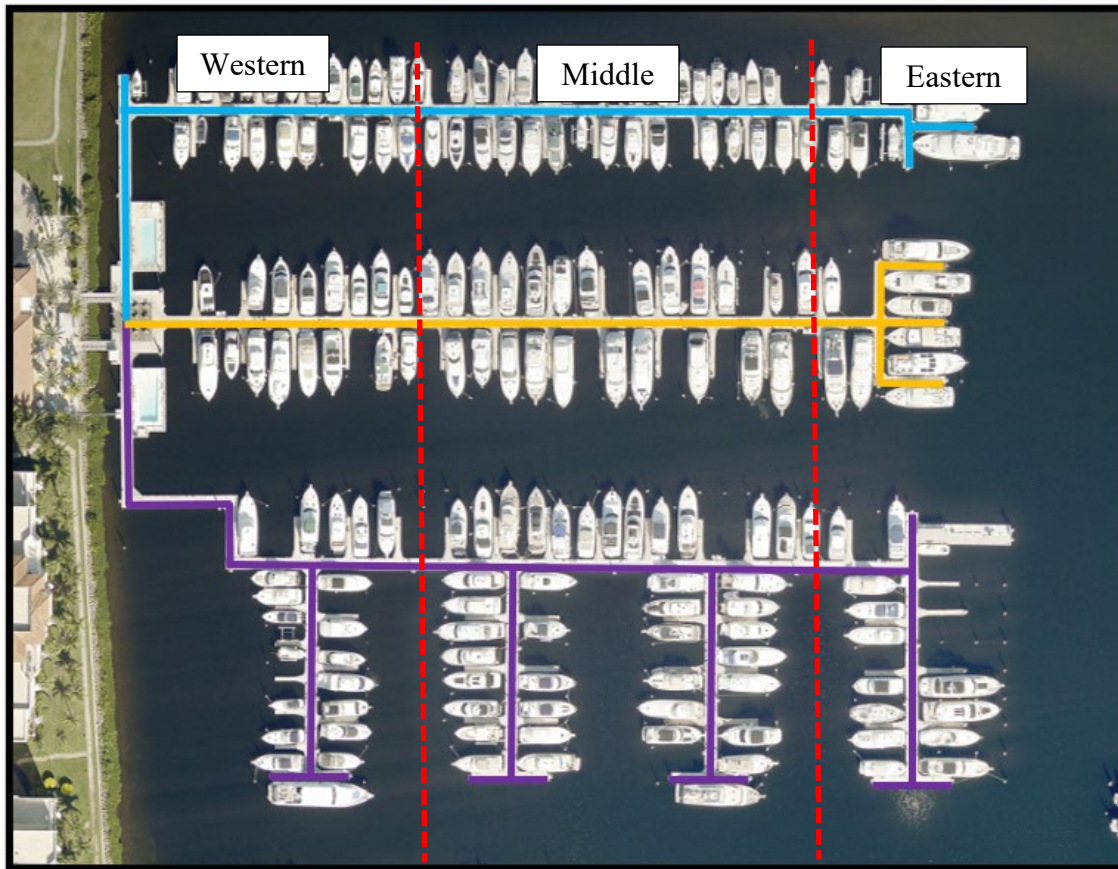
Overall, the floating docks are showing defects common to their age. Typically, the typical design life of floating docks in this environment is 25-years. The docks along the outer edges that are exposed to more wave action and sea spray are in poorer condition relative to the interior portion of docking facility. This is very evident when you split the marina into thirds going from the seawall out to the main waterbody: Western, Middle, Eastern.

Approximately 28% of the docks and finger piers in the western third are in usable condition, approximately 27% of the docks and finger piers in the center third are in usable condition, and approximately 22% of the docks and finger piers in the eastern third are in usable condition. It was also observed that the rate of “Severe” or “Very Poor” condition was far greater in the docks located in the eastern third (see Appendix A).

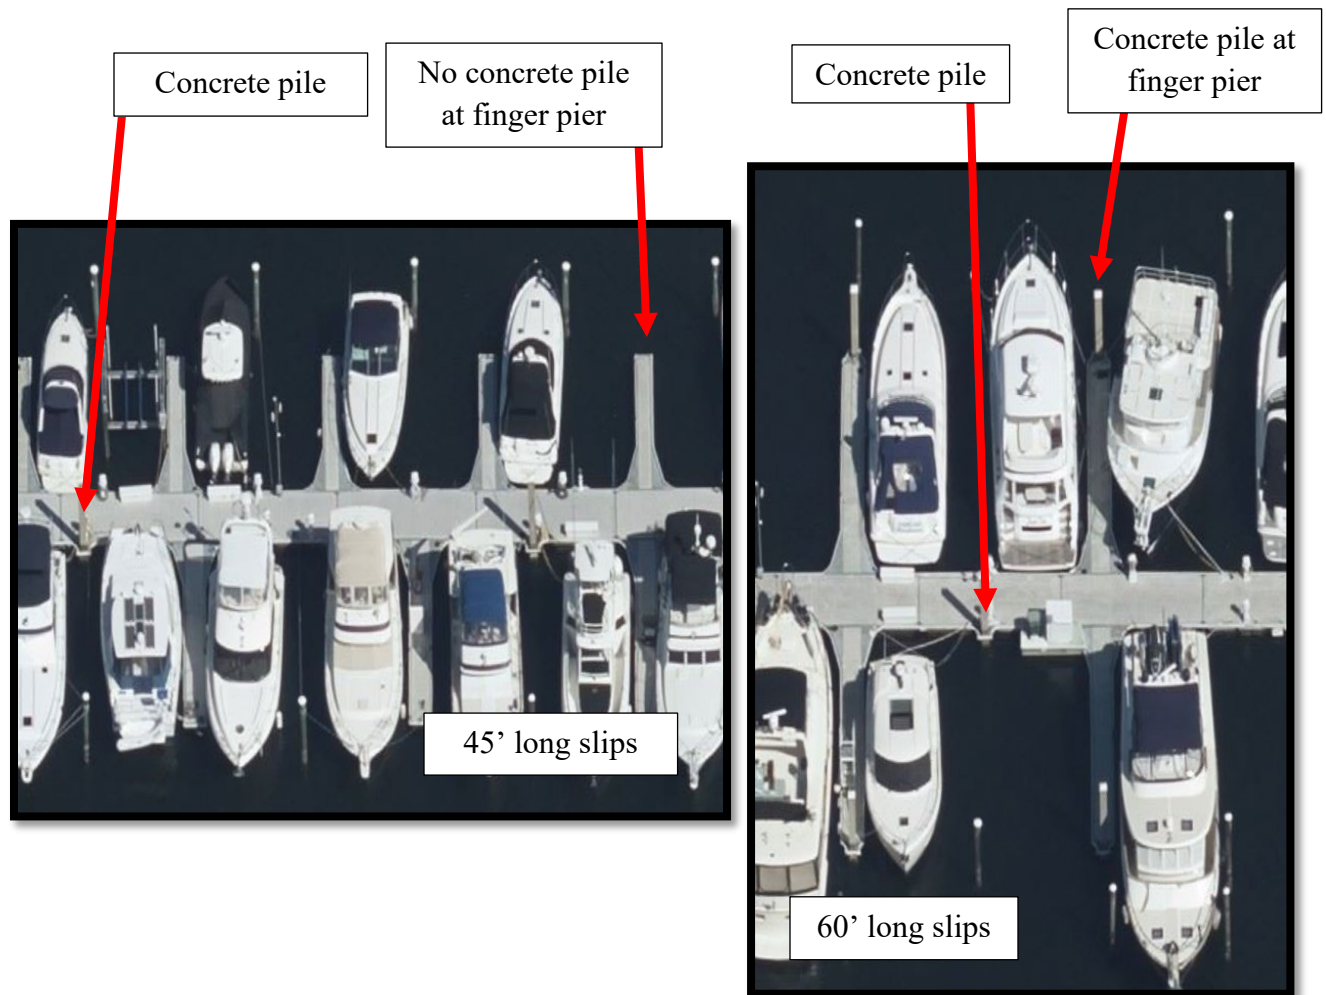
The existing pile size and number of piles used to anchor the docks/vessels was reviewed, and calculations were run for 45' slips and 60' slips. The main difference between the 45' long slip vs the 60' slip is that the 60' slips have concrete piles at the terminal ends of the finger piers. Calculations were performed based on maximum tropical force storm winds of 74 MPH, because any winds above this amount (hurricane force) typically result in the vessels being vacated from the slips.

The results of the calculations are as follows:

- The loading on the wood mooring piles at the 45' long slips is 33% greater than the allowable capacity.
- The loading on the wood mooring piles at the 60' long slips is 1.5 times greater than the allowable capacity.
- The loading on the concrete piles at the 45' long slips is nearly 3 times greater than the allowable capacity.
- The loading on the concrete piles at the 60' long slips is nearly 4 times greater than the allowable capacity.

When the dock replacement is undertaken, additional piles will be required to ensure that the piles are not overloaded.

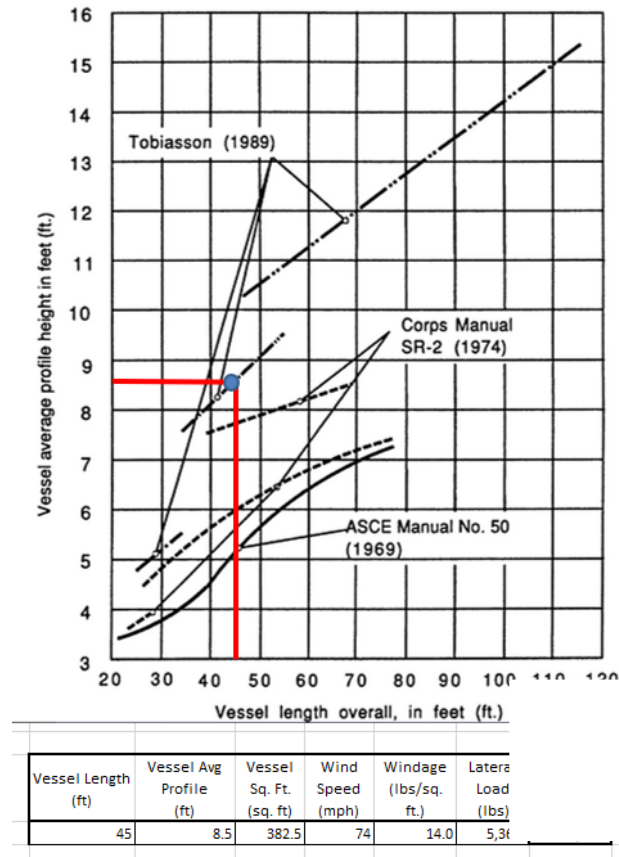
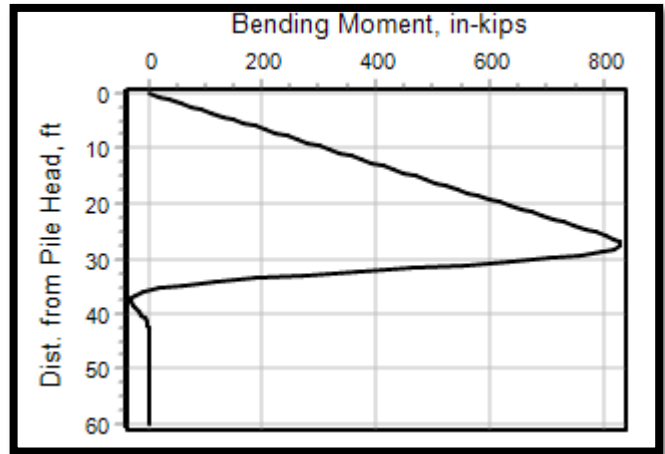
**Borer Worm Damage** – Borer worm damage is present in the piles; therefore, a reduction of the capacity of the wood mooring piles should be assumed. It is very difficult to determine the section loss of each pile unless you slice the pile. For this reason, a section loss of 2” of diameter can be assumed, so for the sake of the calculations, the 14” diameter pile was given a net 12” effective diameter. This equates to the following:

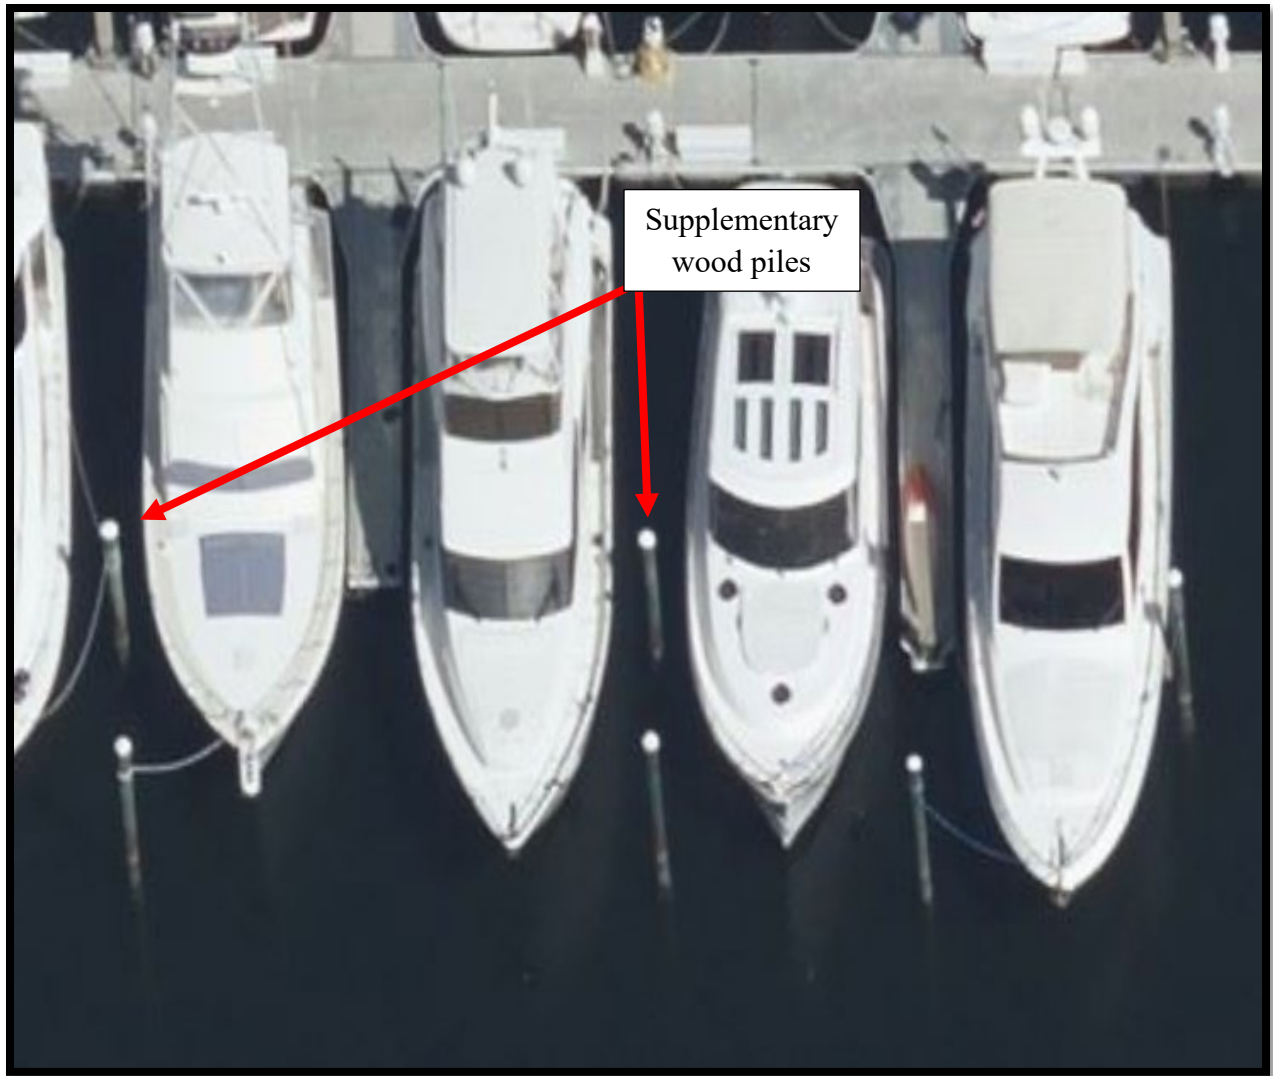
- The loading on the wood mooring piles at the 45’ long slips is 1.6 times greater than the allowable capacity.
- The loading on the wood mooring piles at the 60’ long slips is 2.5 times greater than the allowable capacity.

It should be noted that these calculations assume a significant elevated tide, which is commonly associated with tropical systems. It was also observed that some slips appeared to have supplemental wood piles which will help reduce the stress on the existing wood piles.
